USING MULTIPLE REMEDIAL STRATEGIES TO ATTAIN NFA AT A BROWNFIELD

David Bushong (Environmental Operations, Inc.), St. Louis, Missouri, USA (daveb@environmentalops.com)
 Tim Hippensteel (Environmental Operations, Inc.), St. Louis, Missouri, USA

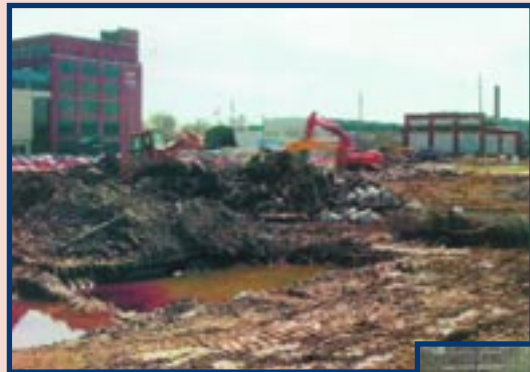
Figure 1. Site Contamination

The former Wagner Electric facility located in Wellston, St. Louis County, Missouri, was impacted with soil and groundwater contamination (Figure 1) from a variety of contaminants. At approximately 15 acres, the site supported a century of industrial use.

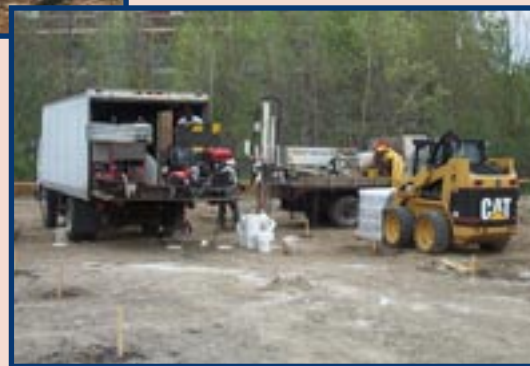
Figure 2. HRC Injection

Enhanced anaerobic bioremediation (reductive dechlorination) through the direct injection of Hydrogen Release Compound (HRC[®]) (Figures 2 and 3) was selected as the remedial option of choice for the groundwater. All work was overseen by the Missouri Department of Natural Resources' (MDNR) Voluntary Cleanup Program (VCP) and the Missouri Department of Economic Development's Brownfield Program for remediation tax credits.

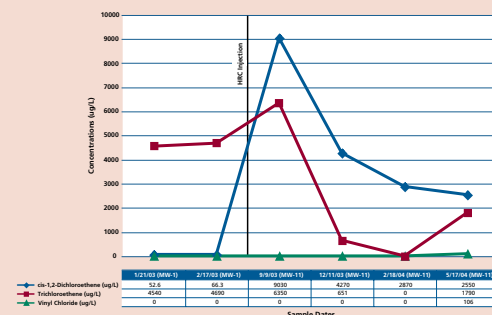
Figure 5. Concentrations at MW-1 and MW-11*

* MW-1 and MW-2 were abandoned prior to HRC injection due to site development. MW-11 and MW-12 were installed after HRC injection in the vicinity of the previous wells.

The very high initial concentrations of TCE found in the heart of the contaminant plume were quickly and effectively reduced immediately following the injection of HRC. Dramatic decreases in TCE concentrations were observed in monitoring wells MW-11, MW-12, and MW-13 over the twelve month post injection monitoring period.

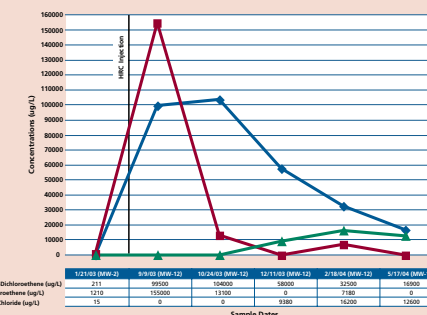
Figure 6. Concentrations at MW-2 and MW-12*

The most significant reduction in TCE concentration occurred in MW-12 with a decrease of over 99% between the first and the most recent groundwater sampling events (155,000 µg/L to less than 5 µg/L).
