## Enhanced LNAPL Recovery – Kent, UK

### PetroCleanze key to removal of adsorbed petroleum hydrocarbons

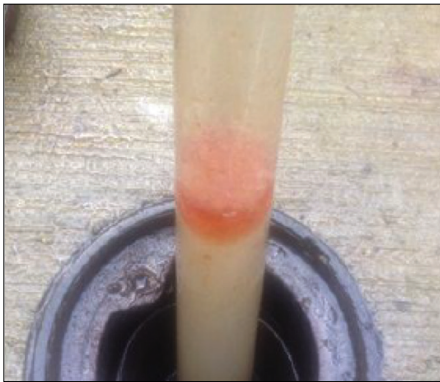
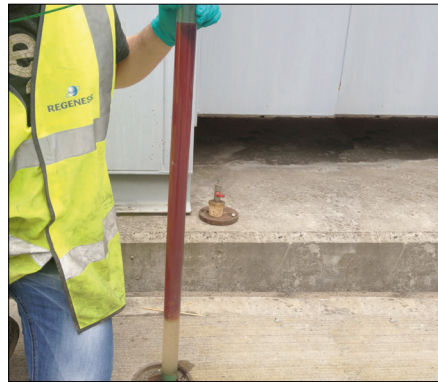
LNAPL recovery pre and post treatment

This treatment method avoided the need for excavation and the disturbance and on-going cost of an active pump and treatment system. Considerable adsorbed mass was encountered onsite, with PetroCleanze increasing the LNAPL available for removal at one well from a few mm to almost 1m. In this way PetroCleanze enhanced the efficacy and certainty of the contaminant removal and site remediation.
