# Treatment of Chlorinated Solvents in Bedrock, Germany

## HRC Barriers Treat Contamination in Sandstone under a School

with consultant: AMEC

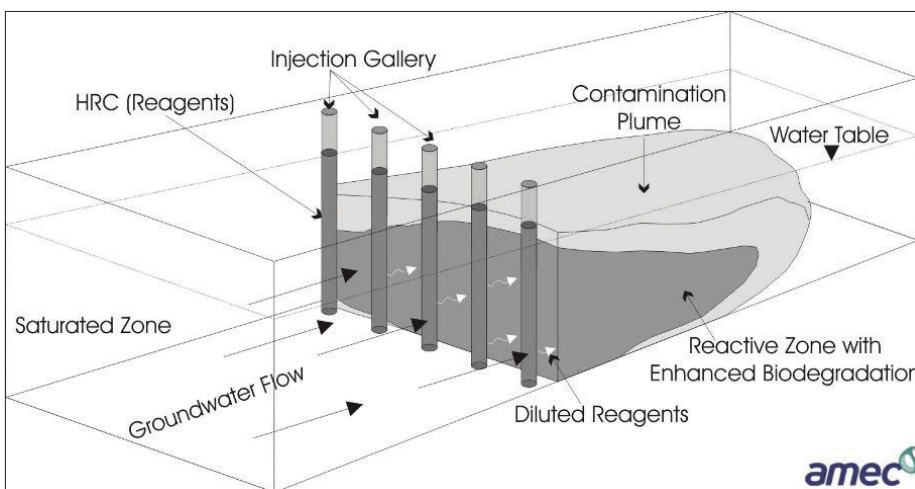
Four rows of application wells were drilled into the bedrock across the site, perpendicular to the groundwater flow. HRC and HRC X were gravity-fed into the wells in order to disperse and diffuse into the surrounding bedrock. This created and maintained four optimum zones of enhanced reductive dechlorination, through which groundwater would pass, but the chlorinated solvent contamination would be degraded.
