# Treatment of Chlorinated Solvents in Bedrock, Germany

## HRC Barriers Treat Contamination in Sandstone under a School

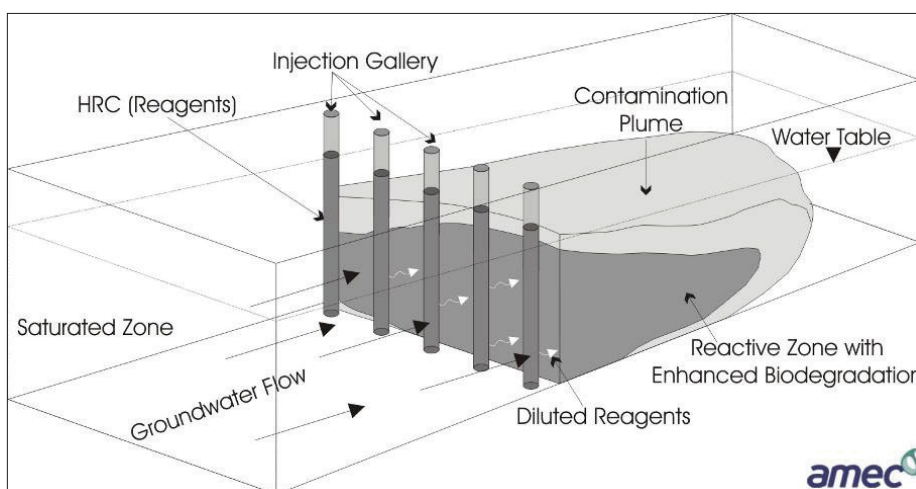
Four rows of application wells were drilled into the bedrock across the site, perpendicular to the groundwater flow. HRC and HRC X were gravity-fed into the wells in order to disperse and diffuse into the surrounding bedrock. This created and maintained four optimum zones of enhanced reductive dechlorination, through which groundwater would pass, but the chlorinated solvent contamination would be degraded.

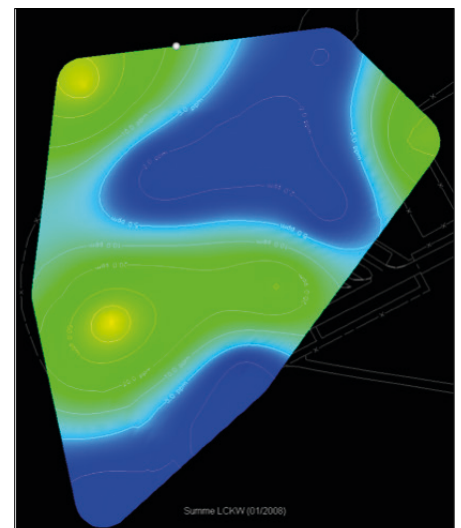
Total CHC, Jan 2008

- 4 monitoring wells below detection limit
- 2 monitoring wells below 3 µg/l
