# Active Petrol Filling Station, North Italy

## In-Situ Enhanced Desorption of Petroleum Hydrocarbons

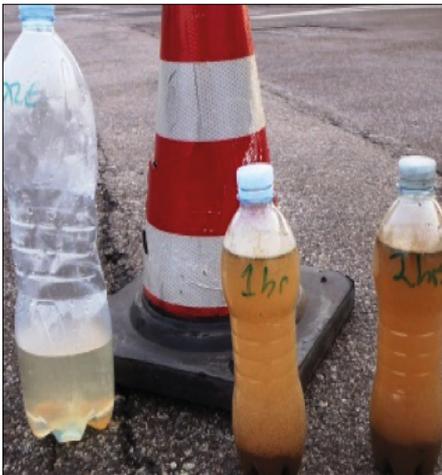
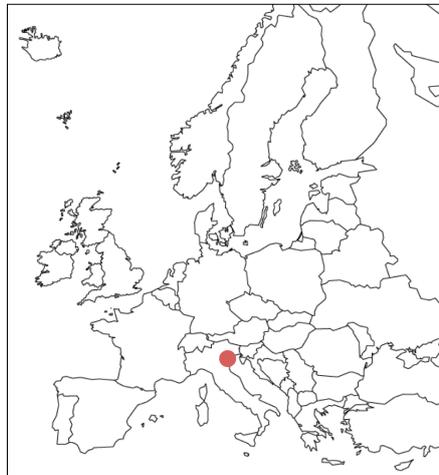
Desorption of TPH was observed two hours after application (see image) and product was successfully recovered during the two vacuum extraction events - dramatically improving the recovery rate of previously observed on site and achieving removal of free product.

Regenesi's PetroCleanze was injected across two extraction locations. Following application, PetroCleanze was left for a period of seven to fifteen days to actively desorb the LNAPL into the groundwater where it was then easily recovered using a vacuum extraction tract.
