Remediation of the largest train maintenance depot in Northern Europe

CASE STUDY

Integrated remedial approach achieves >99% reduction and prevents future recontamination

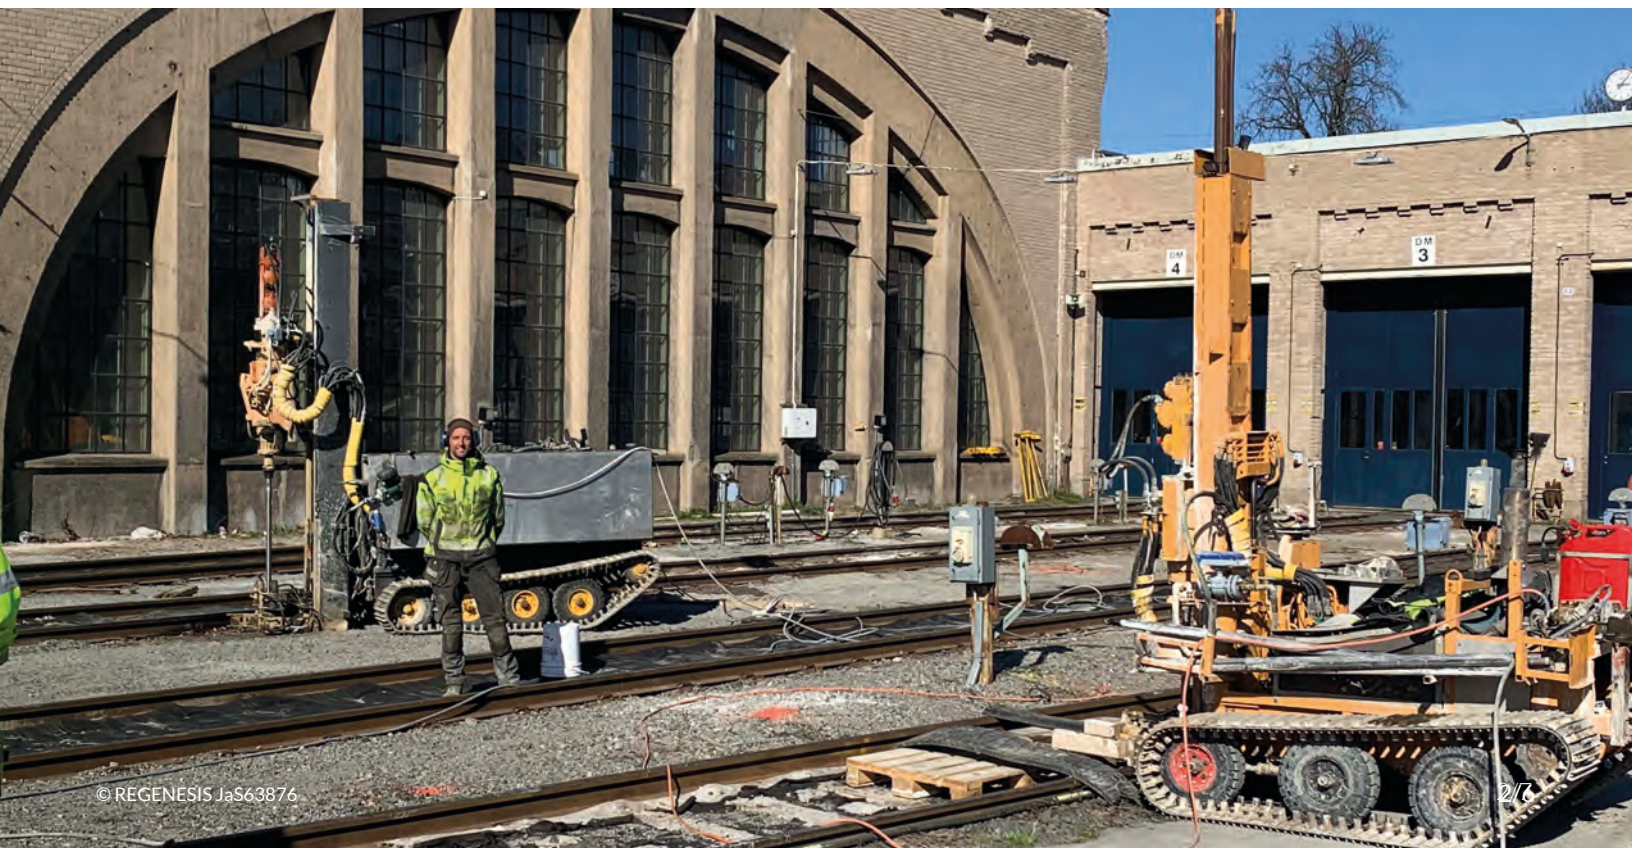
Below: Envytech carried out the injections using Direct Push rigs; **Cover image:** Aerial view of Hagalund depot. © Envytech

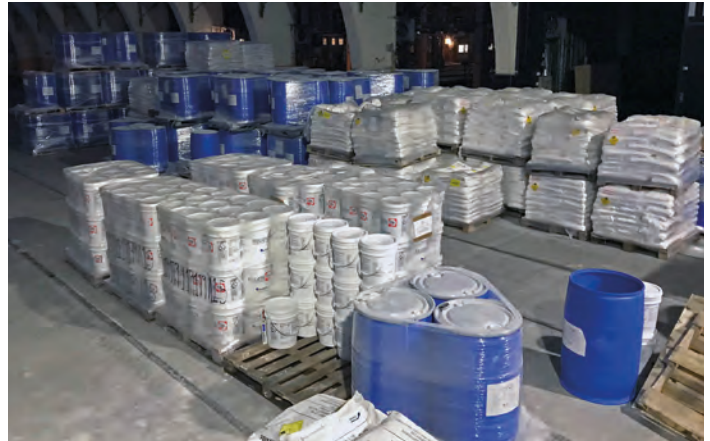
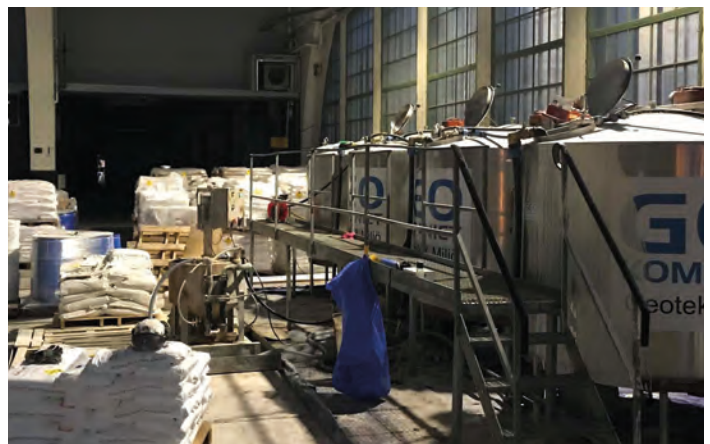
Top: PetroFix, RegenOx and ORC-Advanced storage onsite. **Above:** Envytech's reagent mixing setup. **Below:** Direct Push Injection rigs in action.

- Installation of 62 monitoring wells
- Installation of a dual phase abstraction system which recovered 40 tonnes of free phase hydrocarbons over 6 months
- 3,487 Direct Push Injections Points to apply:
 - 110,000 kg RegenOx
 - 53,000 kg ORC-Advanced
 - 56,000 kg PetroFix

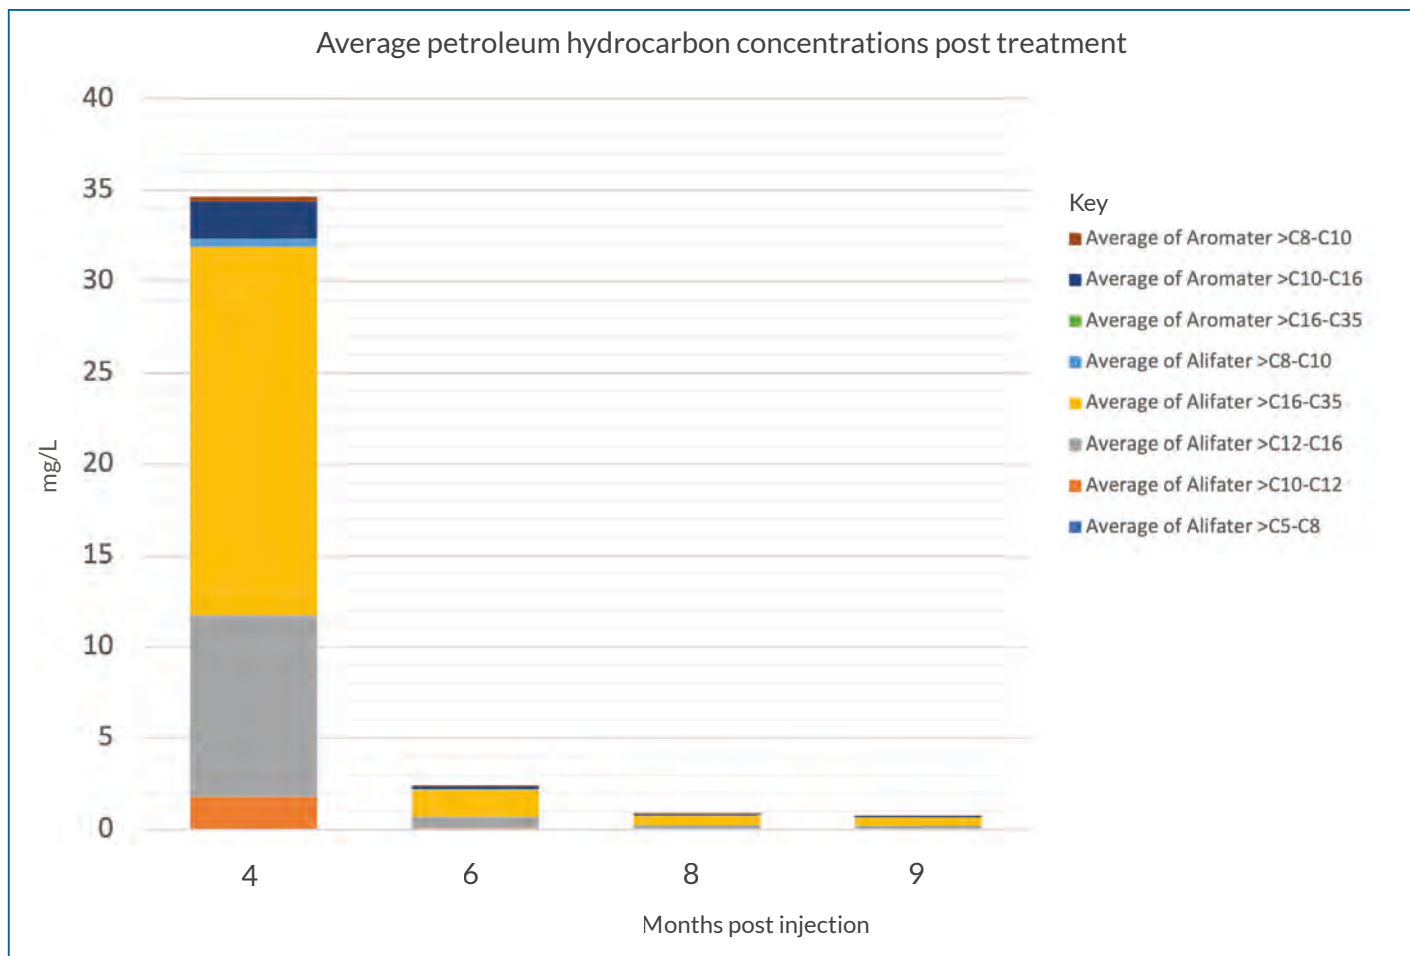
Validation monitoring started 4 months after the works were completed. The graph below show the average petroleum hydrocarbon concentrations post injection, from which a >99% reduction can be observed within 9 months. 3 months of further monitoring is yet to be completed.
