PetroFix Integral to Site Closure Strategy

Reducing Time and Cost-to-Closure at UST Release Sites

BJAAM uses PetroFix to Rapidly Close Petroleum UST Sites

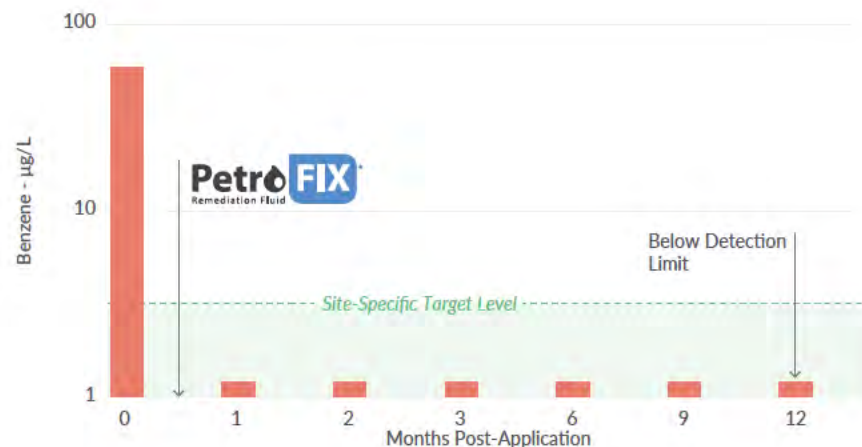
Benzene Concentrations in TMW-9/9R

Benzene results in TMW-9/9R following PetroFix injection

The PetroFix injection reduced the benzene concentration below the 5 µg/L SSTL by the first post-sampling event. The concentrations remained reduced during the year-long performance monitoring period. Based on the PetroFix injection performance results, BUSTR granted the site a No Further Action status.

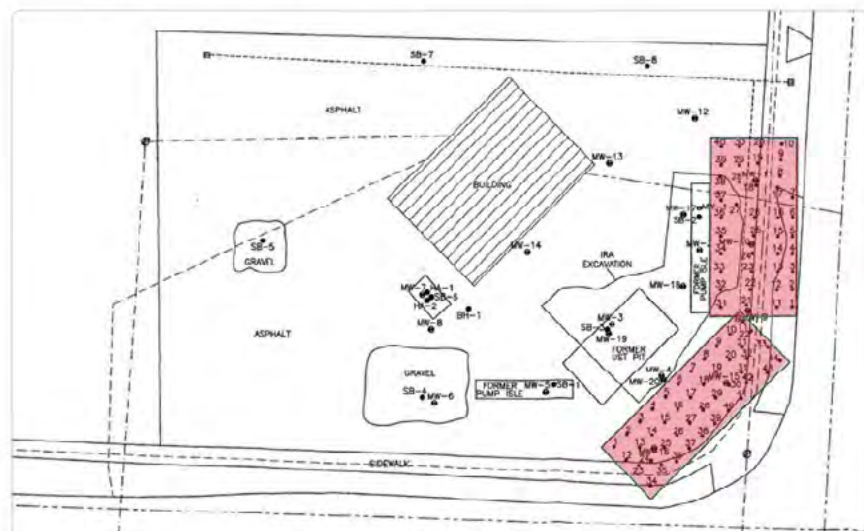
A Phase 1 Environmental Site Assessment was completed in 2016, revealing a former UST system removed from the site in 1983. BJAAM conducted a BUSTR Tier 1 Evaluation in 2017 and, in 2018, completed an Interim Response Action which included the removal of 554 cubic yards of soil impacted by the former UST operations. Following the excavation, residual benzene and methyl-tert-butyl-ether (MTBE) remained above preliminary action levels (i.e., drinking water levels) in groundwater. In 2019, BJAAM completed the PetroFix injections as part of a Remedial Action Plan to reduce the benzene and MTBE concentrations in two areas where the residual impacts remained. A total of 84 direct-push injection points were used for the treatment.

PetroFix injection plan – Brook Park, Ohio

The treatment sharply reduced the contaminant levels and markedly shrunk the impacted area. MTBE concentrations were reduced below the drinking water action level, while benzene exceeded the drinking water action level in a single monitoring well. BJAAM utilized BUSTR’s Tier Evaluation Process, performing fate & transport modeling to demonstrate the lack of a complete exposure pathway for the remaining benzene levels. Based on these results, BUSTR granted the site a No Further Action status in 2020.

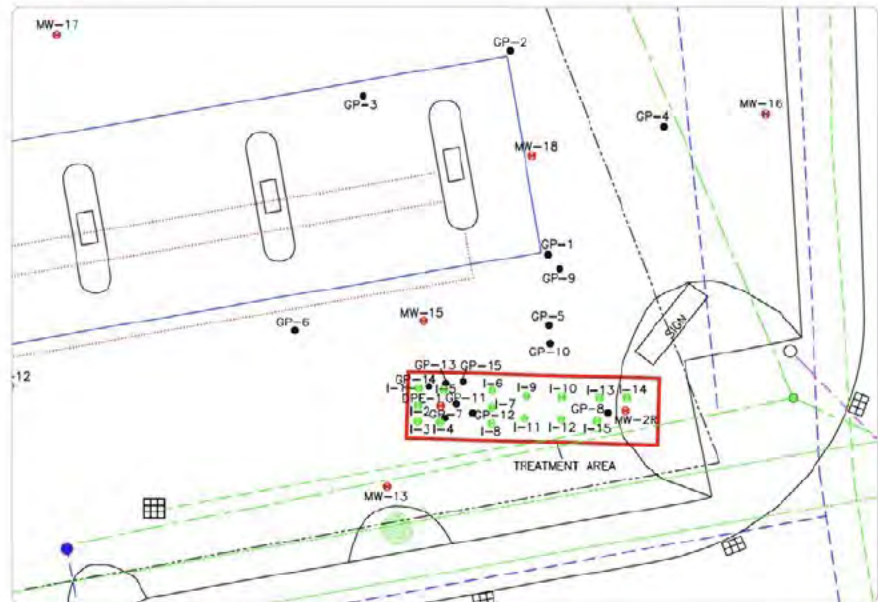
BJAAM proposed PetroFix, developing its own injection design for treating the remaining benzene-impacted area. The remedy was approved by WVDEP and implemented by BJAAM in 2021. The treatment was completed via fifteen direct-push injection points drilled to 16 feet below the ground surface.

PetroFix injection area at Huntington, WV gasoline station.

The PetroFix treatment reduced the benzene concentrations to below detection limits (and the WVDEP action level) by the first post-injection monitoring event (i.e., 30-day event). Concentrations have remained non-detect for one year, meeting the site closure criteria. The WVDEP issued a No Further Action Required letter in early December 2022.

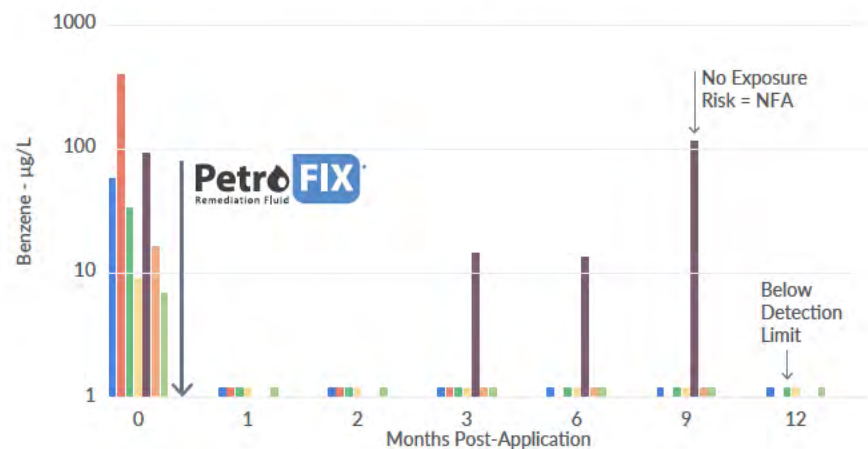
Benzene Reduced Below Detection Limits By PetroFix in Six Out of Seven Monitoring Wells

Monitoring wells used to monitor benzene performance at BJAAM UST sites treated with PetroFix.

- NEOH-TMW-9/9R
- COH-MW-13
- NWV-MW-21
- NWV-MW-23R
- NEOH-MW-10
- NEOH-MW-11
- SWWV-DPE-1

The single-injection PetroFix treatments achieved the cleanup targets (i.e., drinking water action levels or SSTLs) for either benzene or MTBE in nine out of ten monitoring wells used to track performance in the treatment areas. In most treatment areas, contaminants have been reduced and sustained below the laboratory detection limits. At the one treatment area where the benzene SSTL was not achieved, BJAAM conducted an additional evaluation revealing no complete risk exposure pathways, and the site was granted closure.

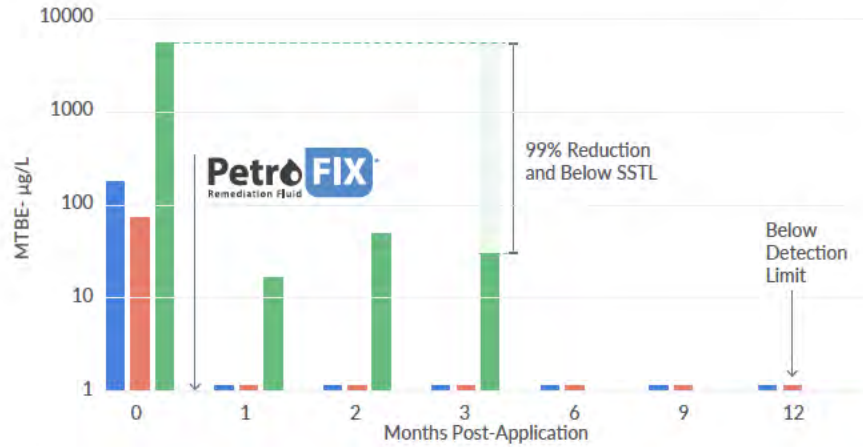
MTBE Concentrations - All Sites

MTBE Performance results at all sites following PetroFix injections.

- NEOH-MW-15
- NEOH-MW-16
- NWOH-MW-5

NWOH-MW-5 is in early stage of performance monitoring (3 months) at time of publishing
