First Application of PetroFix at Petrol Filling Station in Sweden

Integrated groundwater treatment strategy using RegenOx, ORC-Advanced and PetroFix yields a 98% reduction in groundwater contaminant concentrations

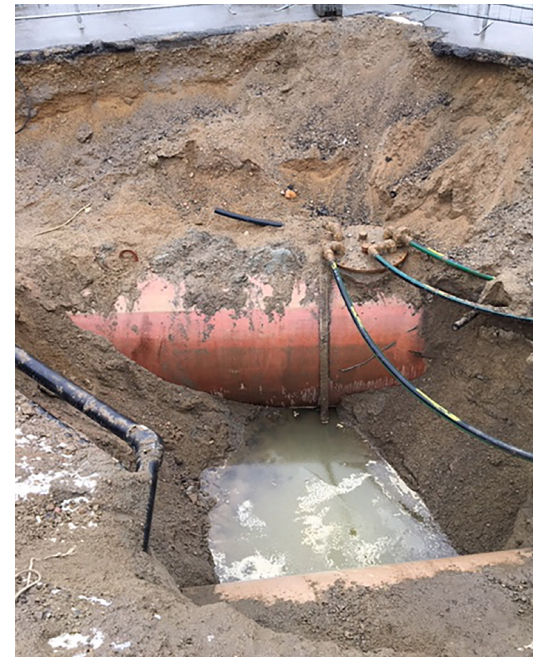
Fig. 1 (top) Targeted excavation around UST
 Fig. 2 (right) Installation of injection wells by RGS Nordic

Where possible, RGS Nordic undertook **targeted excavation** to remove any potential secondary source from the unsaturated soils and during these works REGENESIS recommended that RGS Nordic install a series of injection wells to facilitate the application of reagents into the subsurface around and within the underground tank farm.

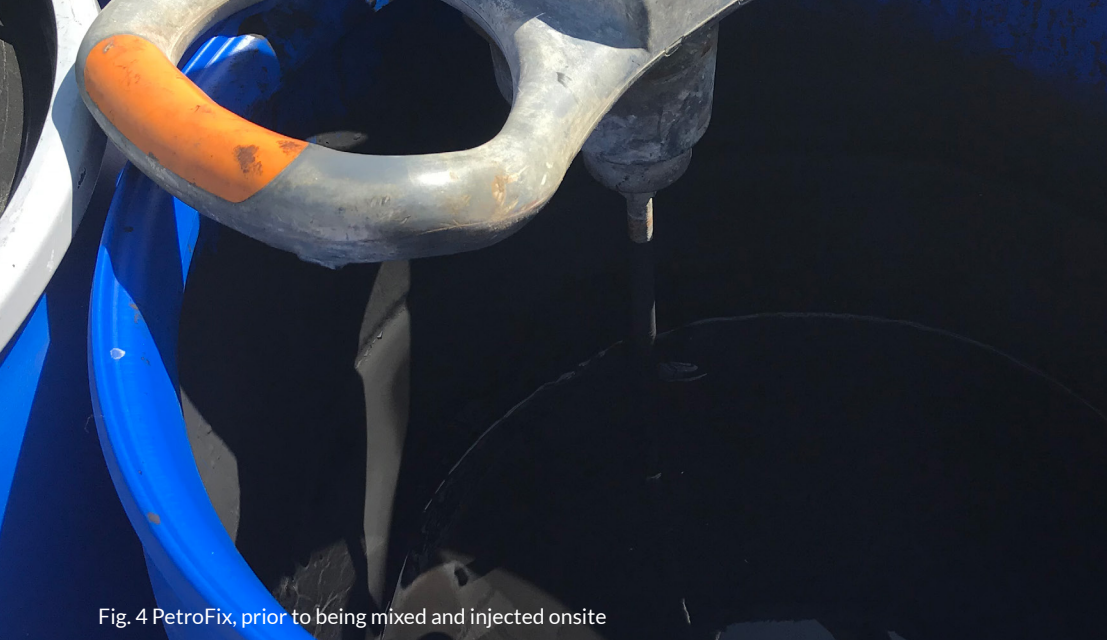
Fig. 4 PetroFix, prior to being mixed and injected onsite

Soon after, PetroFix was injected across the site to **rapidly adsorb and enhance the biodegradation** of the residual TPH and BTEX to accelerate the closeout of the site. PetroFix comprises 1-2µm particles of activated carbon held in a colloidal suspension, which when injected, coats the subsurface with a thin layer of activated carbon.

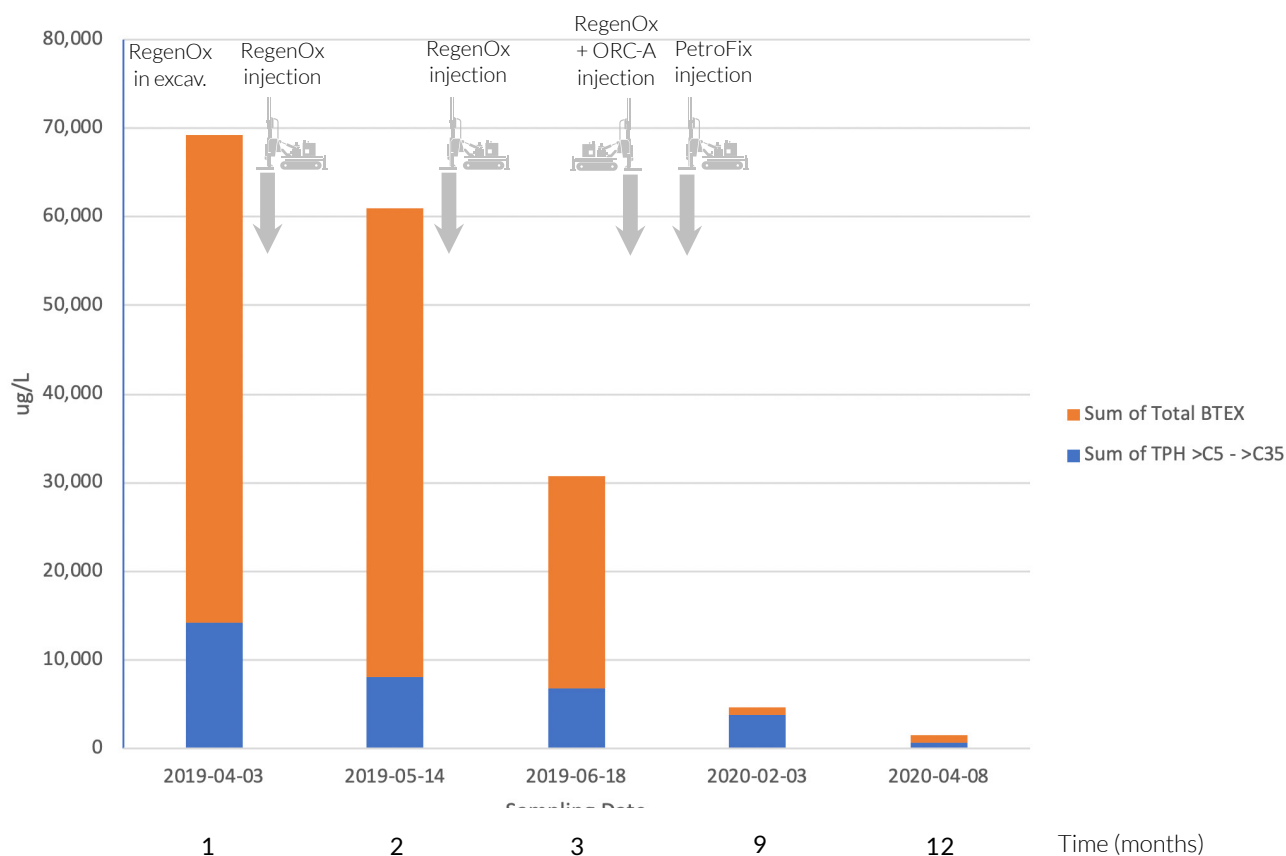
Fig. 5 Total contaminant concentrations (11 monitoring wells)

Monitoring was completed over a **12-month period**. During the first six months, groundwater contaminant concentrations were recorded as each of the remediation phases were completed. This enable RGS Nordic to adapt the remediation strategy as the groundwater conditions changed. Months 6 to 12 represent the validation and verification phases. These results show a **>99% reduction** in contaminant concentrations within the source area (See figure 7) with a reduction in dissolved phase contaminant mass of **98%** across the entire treatment area (See figures 5 and 6).

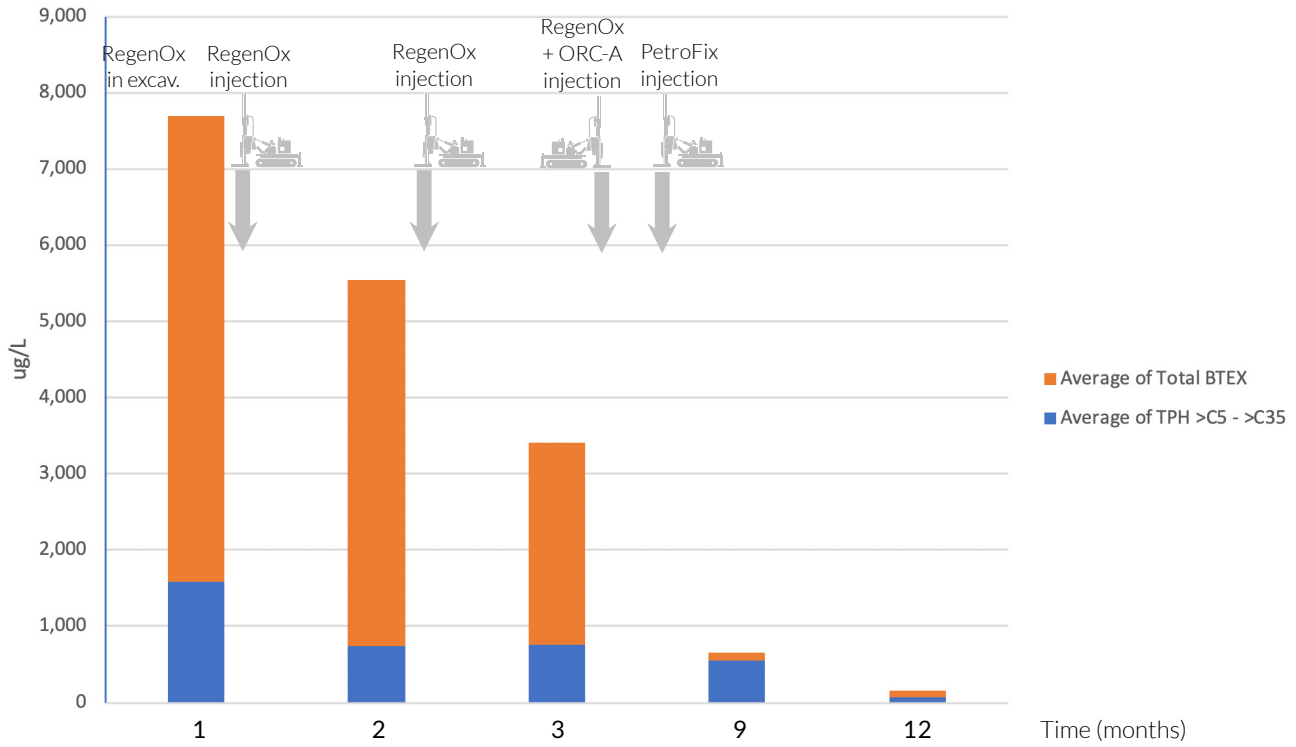
Fig. 6 Average contaminant concentrations across the site

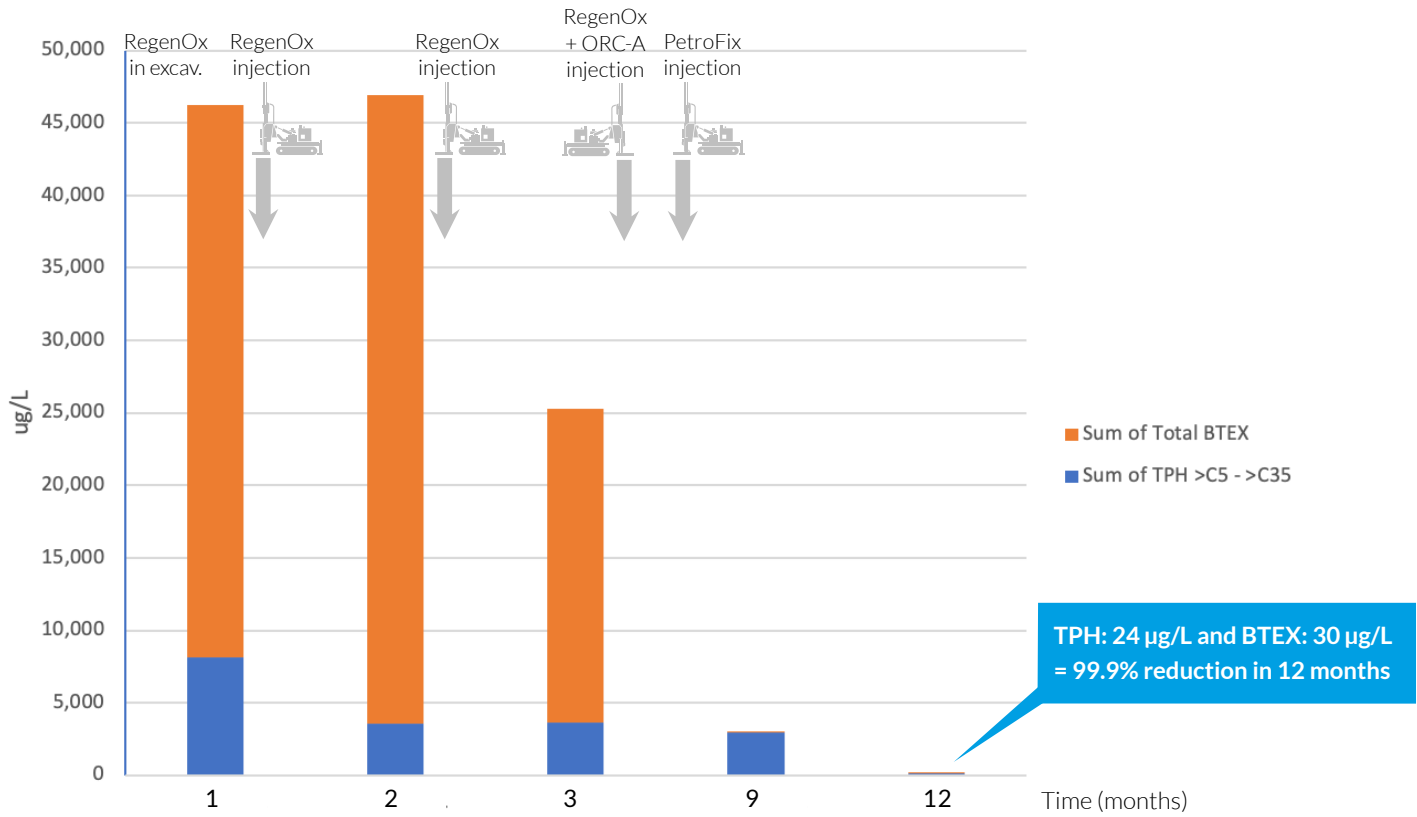
Fig. 7 Source Area Concentrations
