# In Situ Reduction of Hexavalent Chromium

Timely remediation of a former component factory in Northern Switzerland

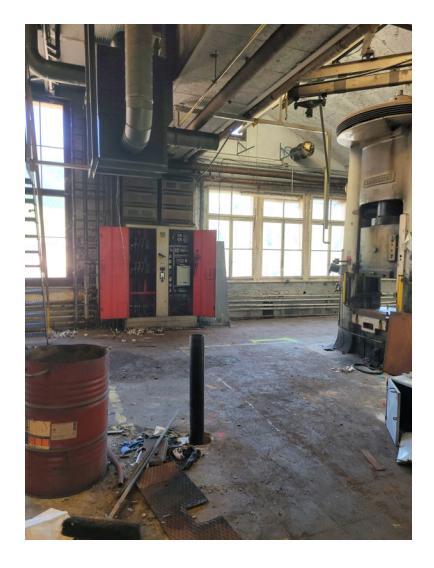
Cover page and above: Indoor remediation activities in the existing historical building (to be retained). Below: the same existing building as seen from the outside.

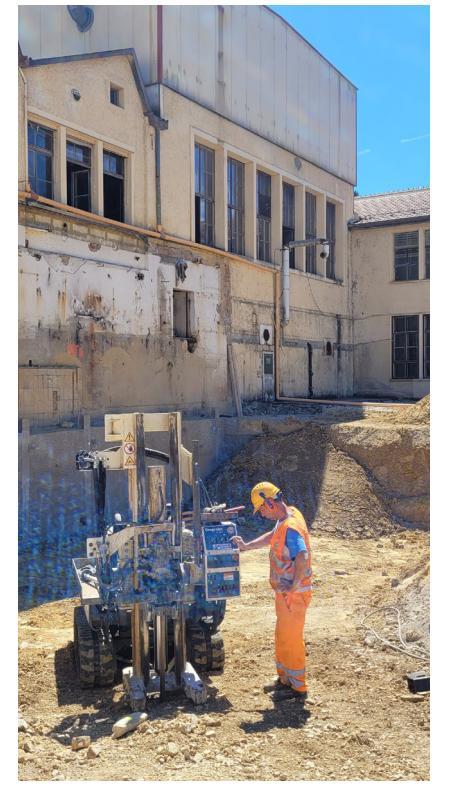
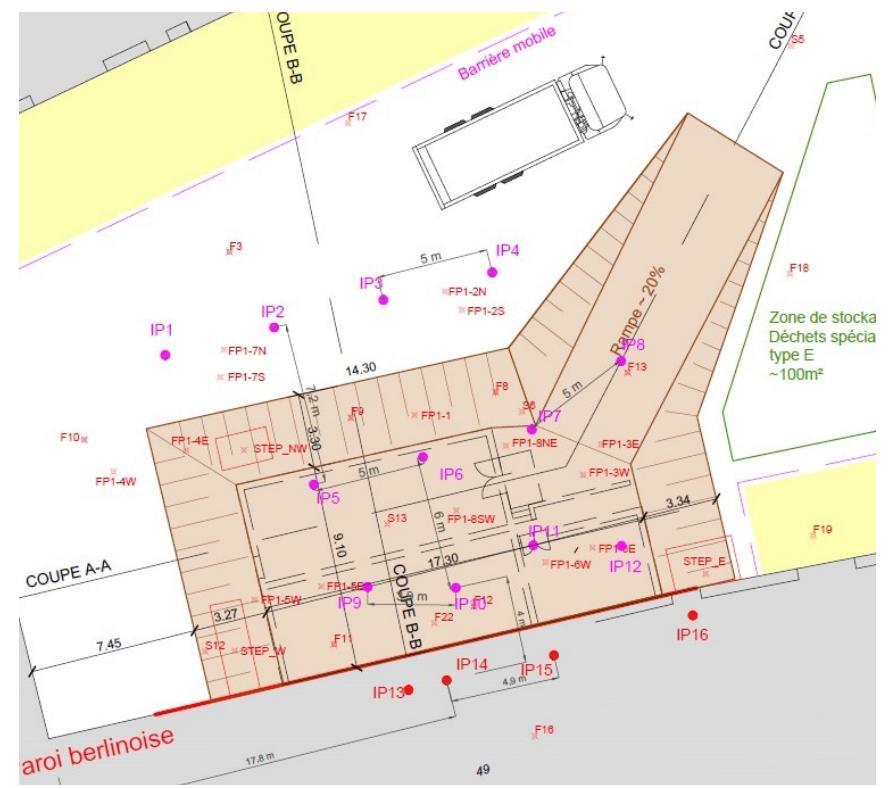
Top left: Indoor direct push injection through the floor slab. Above Left: Direct push injections into the bottom of the excavation. Above right: Site injection plan showing injection points (IP)

Direct Push Technology (DPT) was used to apply the products under low pressure, into the target area. A total of 16 points, forming an irregular grid of 5 x 7 m, was applied. The target aquifer was found at variable depths throughout the treatment area and so an precise vertical injection thickness was used for each point, ranging from 3.5 to 5.0 mBGL. A specialized retractable tip was used to provide even- distribution of the products covering the capillary fringe to the top of the underlying bedrock.

Each injection point used approx. 180 kg 3DME and 30 kg of chemical reducing agent, diluted to form a solution of 900-1300 L per point. The injection points located inside the historical building, needed to be drilled through a pavement several meters above the natural ground level, passing through an inaccessible cavity. These points were predrilled prior to using the DPT injection rig and the holes repaired following application.

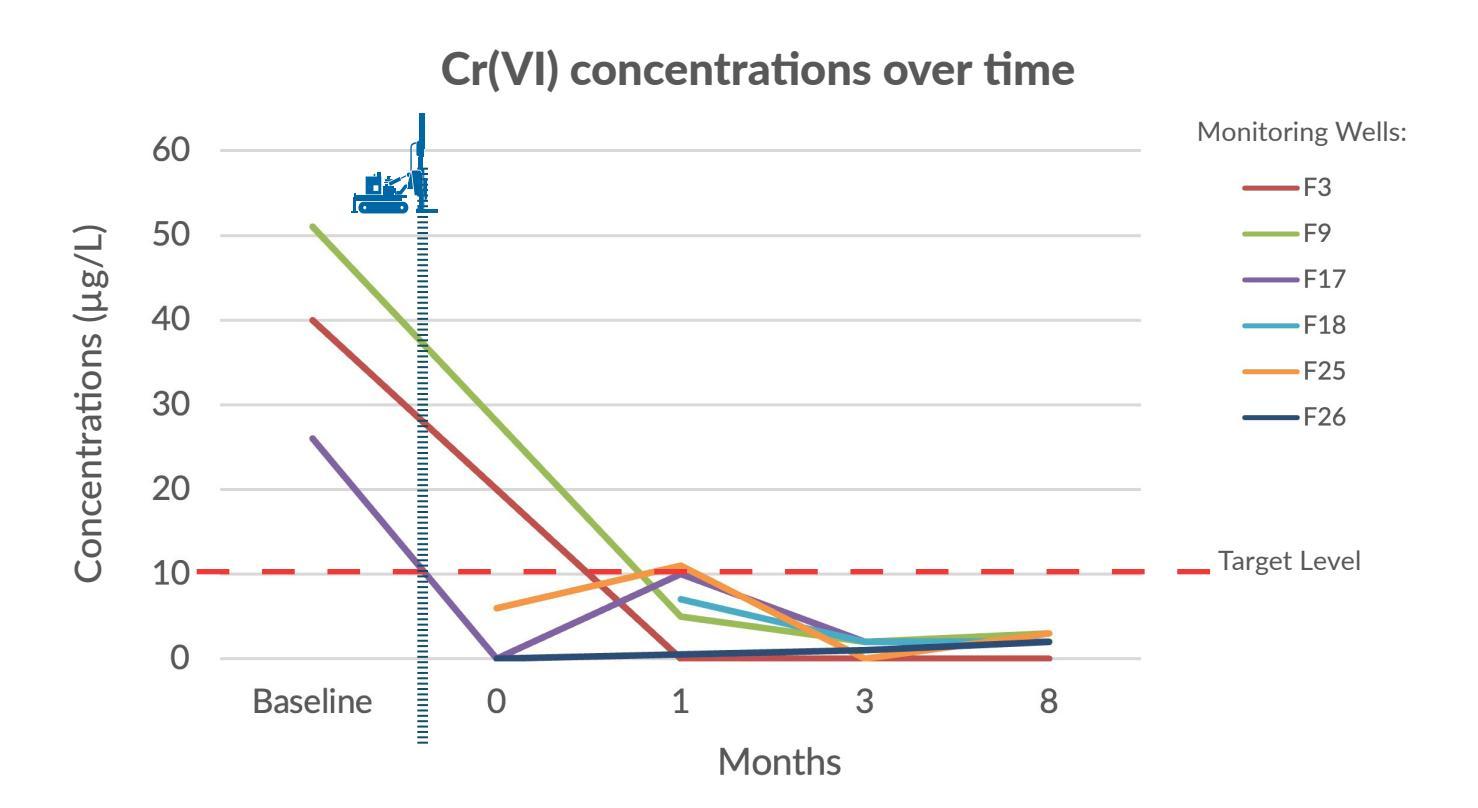
Three months post injection, Cr(VI) had already been completely reduced in the entire monitoring network, located within and downgradient of the treatment area. This included in the 5 compliancy monitoring wells external to the treatment area.

The stringent target of 10  $\mu$ g/L was reached in all wells, with 3  $\mu$ g/L being the maximum level detected and several wells being below detection limit of <1  $\mu$ g/L. These reductions continue to be maintained in the ongoing monitoring. Long term monitoring is continuing for 5 years after achievement of the targets with campaigns every 9 months to observe the stability of the reductions achieved.

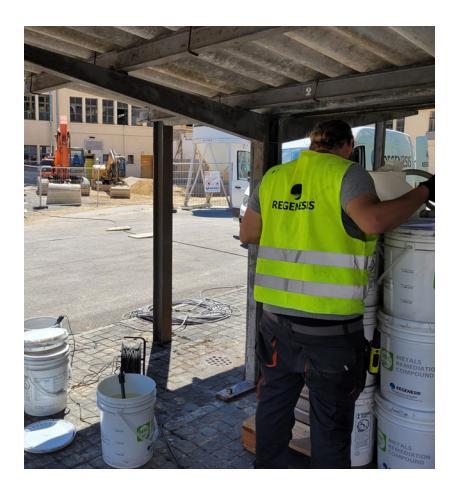
Above: Outdoor mixing area of the remediation reagents Below: Indoor injections made possible with the small footprint of the Direct Push rig.
