Combined remedy rapidly achieves targets to address chlorinated solvent impacts

Remedy quickly reduces CVOC concentration below targets, priming site for future closure

Active Industrial Facility in Southern California Impacted by PCE and TCE

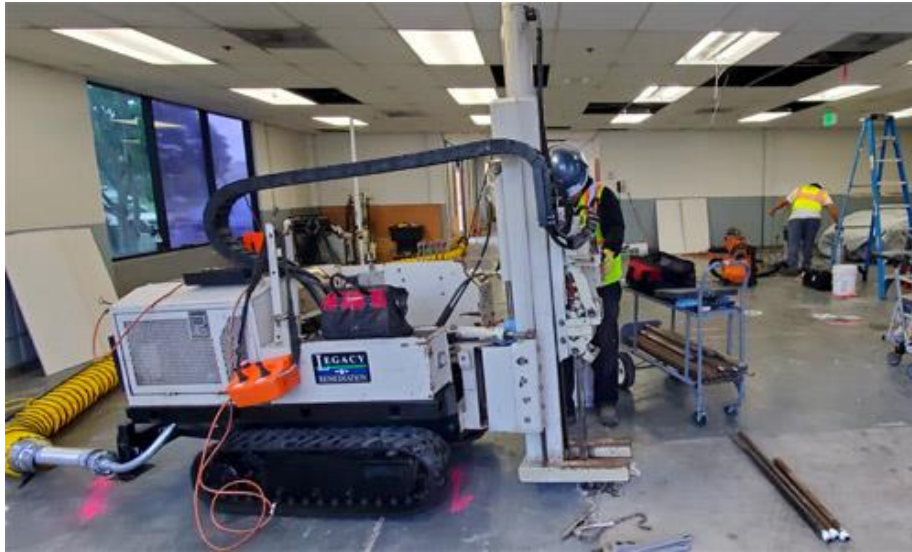
Figure 5. Injections in the building office area at AOC-1.

During DVT mobilization, S-MicroZVI was also applied to 20% or 1,000 square feet of AOC-1. The drilling work was completed in an office area with low overhead clearance, requiring a compact hydraulic percussion (i.e., direct push) rig for the injections, operated by Legacy Remediation (Figure 5). The work required significant coordination between the tenant, Roux, Legacy, and RRS to ensure a safe and healthy work environment for all involved.

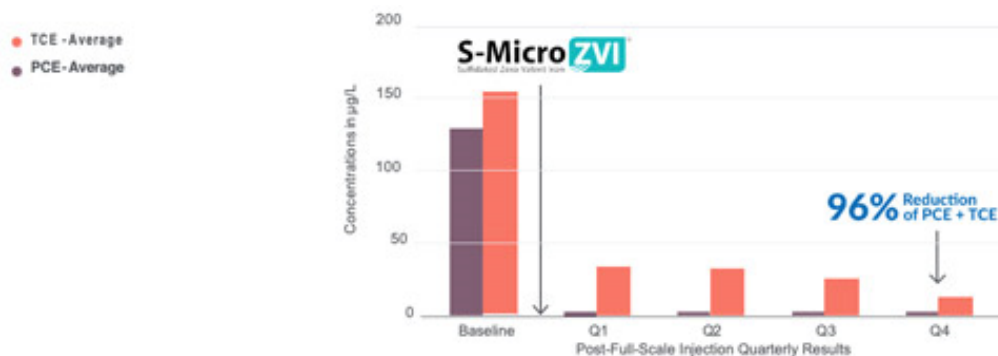
Figure 8. AOC-1 Average PCE and TCE in MW-7s, MW8s, and MW-10s.

- PCE and TCE concentrations have been reduced by an average of 99% and 94%, respectively, resulting in a total CVOC reduction of 96% and below area CVOC background levels after four quarters of performance monitoring (Figure 8).

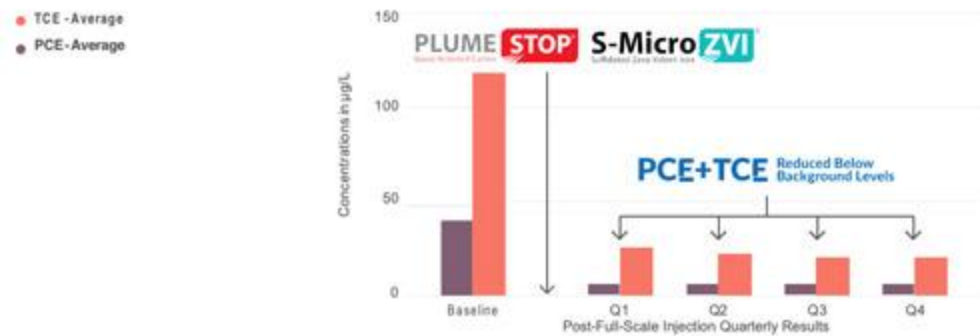
Figure 9. AOC-2, Average PCE and TCE (µg/L) at MW-11s, MW-5s, and MW-12s.

- The PlumeStop and S-MicroZVI barrier has reduced PCE and TCE concentrations below the background levels related to the offsite CVOC source(s) through four quarters of monitoring (Figure 9). These results obtained from the near-downgradient performance monitoring wells demonstrate that the barrier is meeting its performance goal, effectively stopping the CVOC contaminant flux from the site.
- Consistent with other sites where S-MZVI was used to facilitate ISCR, the rapid and sustained PCE and TCE reductions at AOC-1 and AOC-2 were achieved without forming significant concentrations of daughter products cis-1,2-dichloroethene (cis-DCE) and vinyl chloride (VC).
