PlumeStop Application Paves The Way For Redevelopment

Design Verification Testing and
Predictive Modeling Contribute to
Achieving Remediation Goals

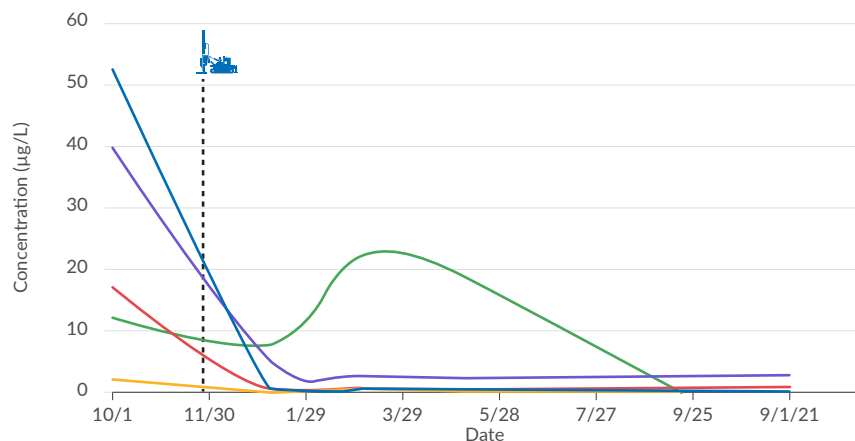
Figure 4

W5-A1 (Downgradient of Barrier 2)

Performance results in the A1-Upper Treatment Zone. Chart data provided by PES.

The remediation has met the predicted performance expectations. After approximately one year post-injection, greater than 90 percent CVOC reductions have been achieved in the main plume area. Reductions have been most pronounced, 98 percent, in the lower A2 Zone thus far, correlating with the overall higher groundwater velocities observed in this zone during the PFM study. Significant concentrations of ethane, an abiotic degradation byproduct, have been observed in both the A1 and A2 Zones, indicating complete degradation of the CVOCs is occurring with little to no daughter product formation.
